**American Petroleum Institute's Review of EPA's Pavillion  
December 8, 2011 Draft Report With Focus On Monitoring Well  
Drilling, Completion, Development, And Sampling Activities  
Related To Deep Monitoring Wells MW-01 And MW-02**

JUNE 25, 2013

Prepared by: The American Petroleum Institute | 1220 L Street, NW | Washington, DC 20005-4070 | [www.api.org](http://www.api.org)

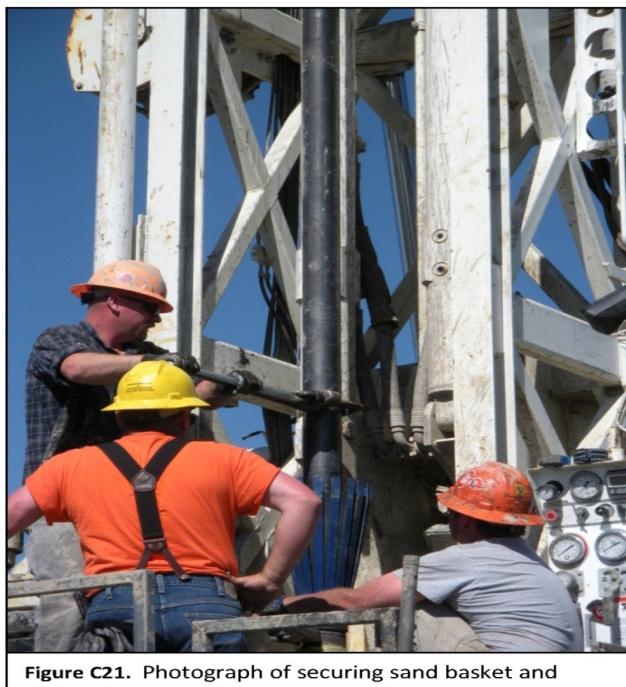
**Figure 1. Photograph<sup>1</sup> of carbon steel casing and sand basket used in the construction of EPA's Pavillion monitoring wells.**

The painted sand basket was welded to the top of the screen in both wells. Welding flux and associated materials can contain metals and organics. There are no records to indicate that once the welding was completed, that the welded portions of the screen and sand catcher were ever decontaminated. If they were not decontaminated, chemicals associated with welding could impact groundwater. The picture (**Figure 1**) provided below (taken from the Draft Report<sup>1</sup>) below shows the blue-painted sand basket and black painted/coated carbon steel casing used by EPA at Pavillion.

**Figure C21.** Photograph of securing sand basket and casing above screen.

The use of painted casing or painted sand baskets (or paint/coatings of any type) in monitoring well completions is essentially unheard of in the groundwater profession, and this fact alone makes any groundwater analytical data collected from either of monitoring wells MW-01 and MW-02 suspect. EPA still fails to point out (but USGS did in their report<sup>4</sup>) that this casing had a black paint/coating applied to it, and further, EPA still fails to point out on the new monitoring well construction diagrams<sup>13,14</sup> that the sand basket was painted blue and contained a black liner of some type, facts EPA were aware of when they posted these revised well construction diagrams<sup>13,14</sup> on their Pavillion website<sup>12</sup> on November 6, 2012, but apparently chose not to disclose.

Examination of the photographs provided in EPA's December 2011 Draft Pavillion Report<sup>1</sup> and **Figure 1** show the sand basket painted blue, approximately 1.8 feet long, possibly rubber/plastic lined, and welded to the top of the stainless steel well screen. A painted sand basket is not shown on figure 6a of EPA's Draft Report<sup>1</sup>.

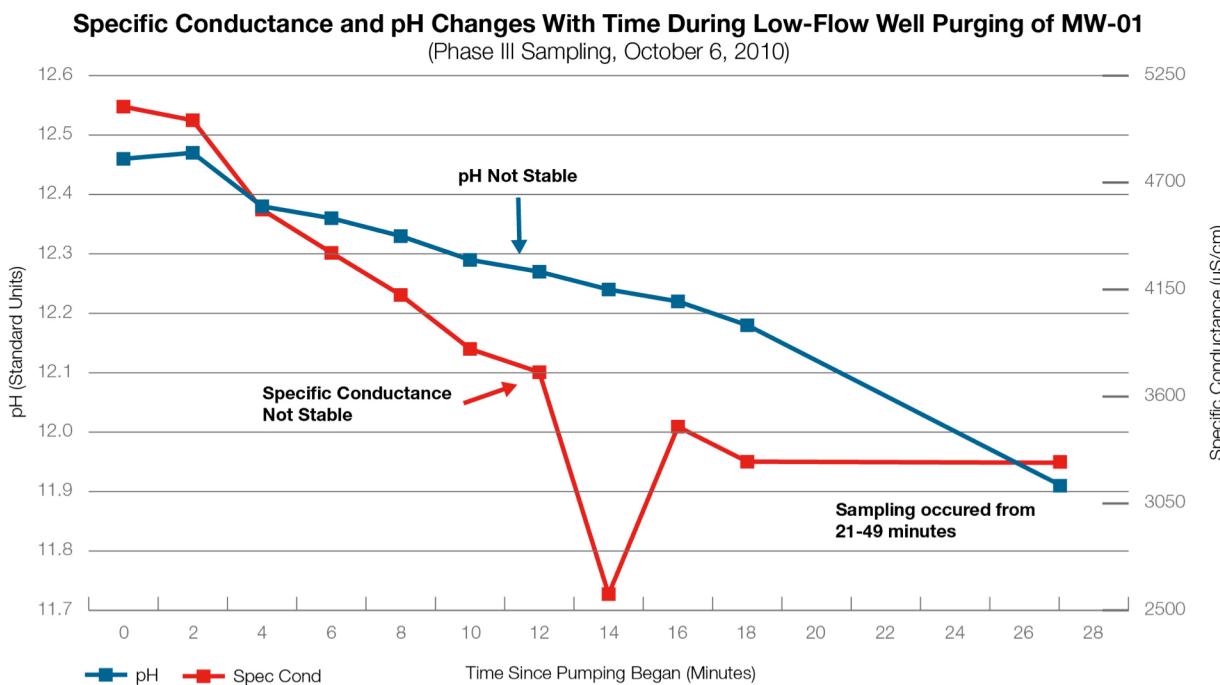
**Figure 2. Graph of pH and specific conductance readings taken during low-flow sampling of MW-01 by EPA during Phase III (October 6, 2010).**

Data provided in **Tables 2** and **3** clearly and concisely show that the pH, oxidation-reduction potential, and specific conductance were not stable in well MW-01 during either of the Phase III or Phase IV sampling events, contrary to EPA's statement noted earlier on page 20 of their Draft Report<sup>1</sup>. **Figures 2** and **3** are plots of the pH and the specific conductance data from MW-01 during these Phase III and IV sampling events, respectively, and show the pH and specific conductance instability.

The instability in pH shown in data from **Tables 2, 3, and 4** likely relates to cement contamination of groundwater in monitoring wells MW-01 and MW-02. Any and all groundwater quality data from wells MW-01 and MW-02 should be disregarded as inaccurate and invalid because pH is considered a key geochemical variable and highly controls many geochemical reactions involving both inorganic and organic dissolved solids.

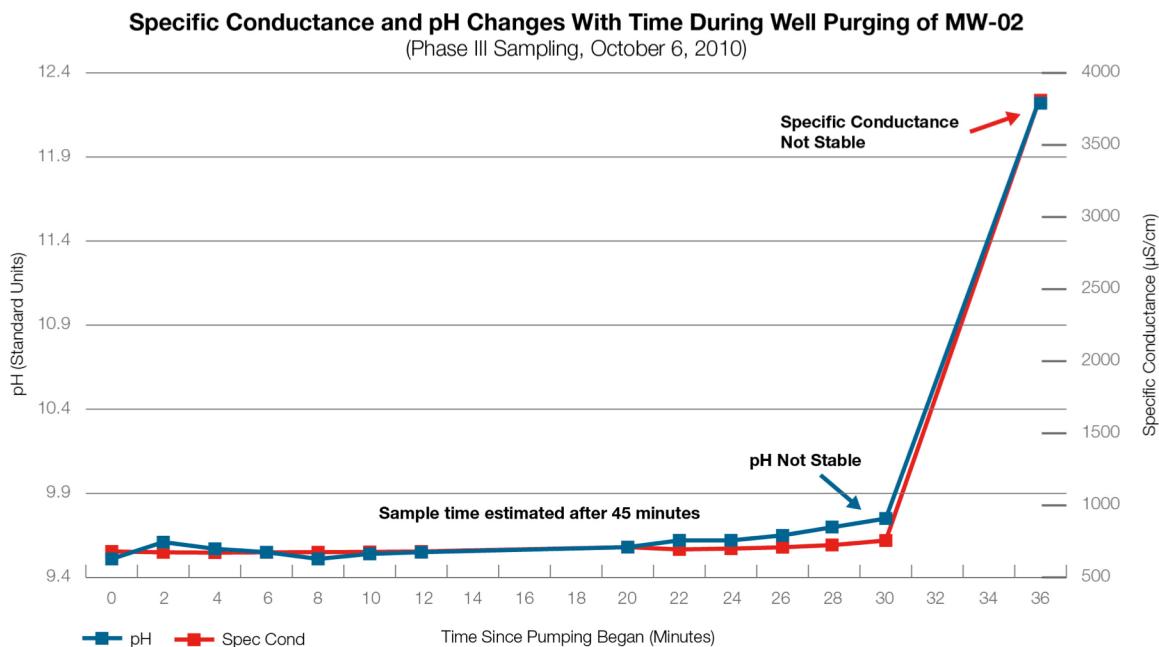
**Figure 4. Graph of pH and specific conductance readings taken during low-flow sampling of MW-02 by EPA during Phase III (October 6, 2010).**

During Phase III sampling of well MW-02, a major change in pH, oxidation-reduction potential, and specific conductance occurred between 30 to 36 minutes into the low-flow pumping period. EPA does not point out this change or discuss possible reasons for the dramatic increase in pH and specific conductance (decrease in oxidation-reduction potential) in MW-02, consistent with cement contamination. Likewise, EPA fails to discuss or point out the lack of stability in the pH, oxidation-reduction potential, and specific conductance during sampling of MW-01 during both Phase III and Phase IV sampling events. The low pH between 9.3 to 9.8 and low specific conductance in monitoring well MW-02 may be due to imported water added and left in the monitoring well during development on September 11, 2010.

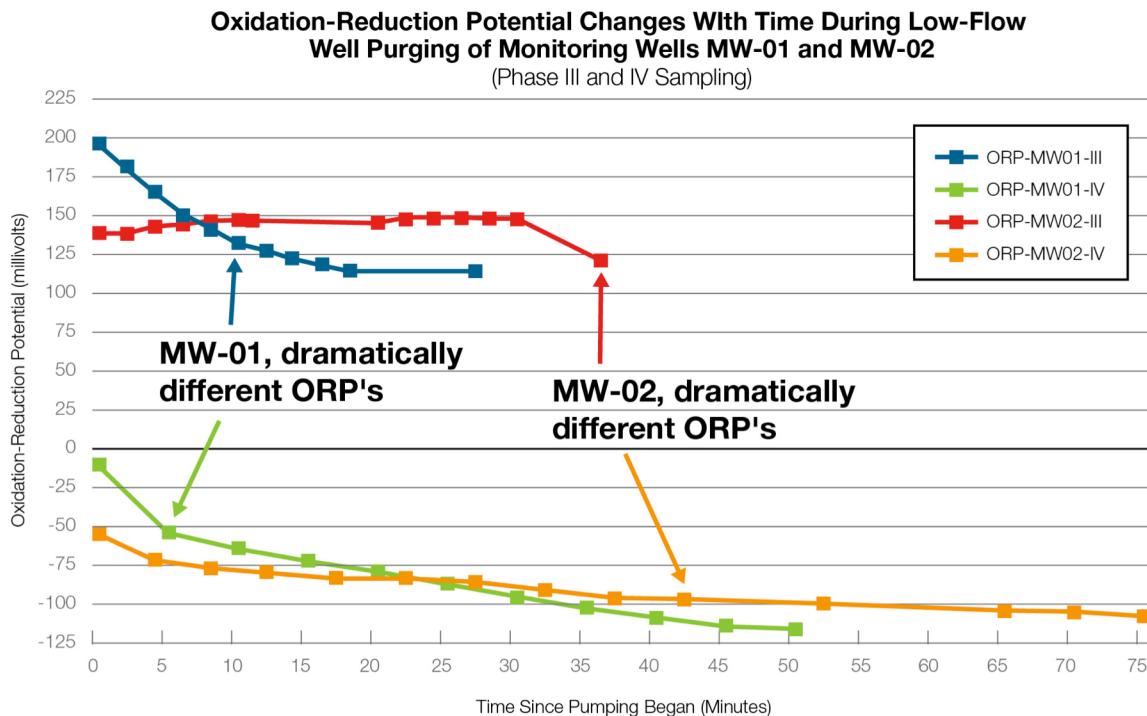
**Figure 5. Graphs of oxidation-reduction potential from low-flow sampling data from monitoring wells MW-01 and MW-02 during the Phase III and IV sampling events.**

**Figure 5** is a graph of the oxidation-reduction potential (ORP) measured in groundwater from monitoring wells MW-01 and MW-02 during the Phase III and IV sampling events. These graphs also show that the ORP was unstable during the low-flow sampling events. **Figure 5** also shows that there is a large discrepancy between the ORP measured in each well between the Phase III and Phase IV sampling events. For example, the ORP measured in monitoring well MW-01 during the Phase III sampling event on October 6, 2010 ranged from 114.3 millivolts (mV) to 196.4 mV. During the Phase IV (April 20, 2011) sampling event, the ORP in this same monitoring well ranged from -10.2 mV to -116.2 mV. A similar discrepancy occurs in the ORP reading from monitoring well MW-02. EPA fails to discuss how such a large difference in ORP readings can occur in groundwater from the same well.

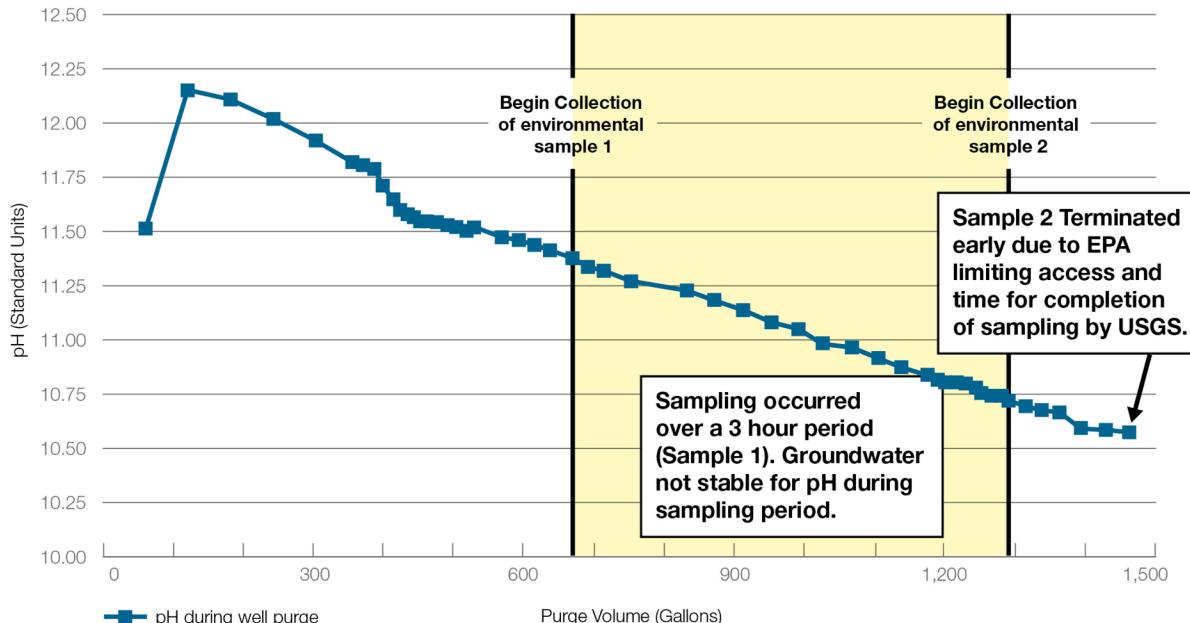
**Figure 6. Modified after USGS Figure 2, Data Series Report 718 (samples collected by USGS on April 24, 2012)**

Although EPA maintains the groundwater was stable (contrary to their own data) during their short-term sampling events on October 6, 2010 and April 20, 2011 from monitoring well MW-01, data from USGS's 2012 report<sup>3</sup> (**Figure 6**) shows that the pH could not have been stable in monitoring well MW-01(sampled by USGS on April 24, 2012), especially since groundwater from this well was not yet stable even after removing approximately five times the volume as removed by EPA on April 20, 2011 and over 12 times the volume removed by EPA on October 6, 2010. The occurrence of cement contamination in the monitoring well water is not unexpected given that the well screens are in contact or near contact with cement. In MW-01, cement is located immediately above and below the screen interval. In MW-02 cement is located immediately above the well screen and drilling mud and cuttings are located immediately below the well screen. Cement also likely invaded the screen interval in both monitoring wells.

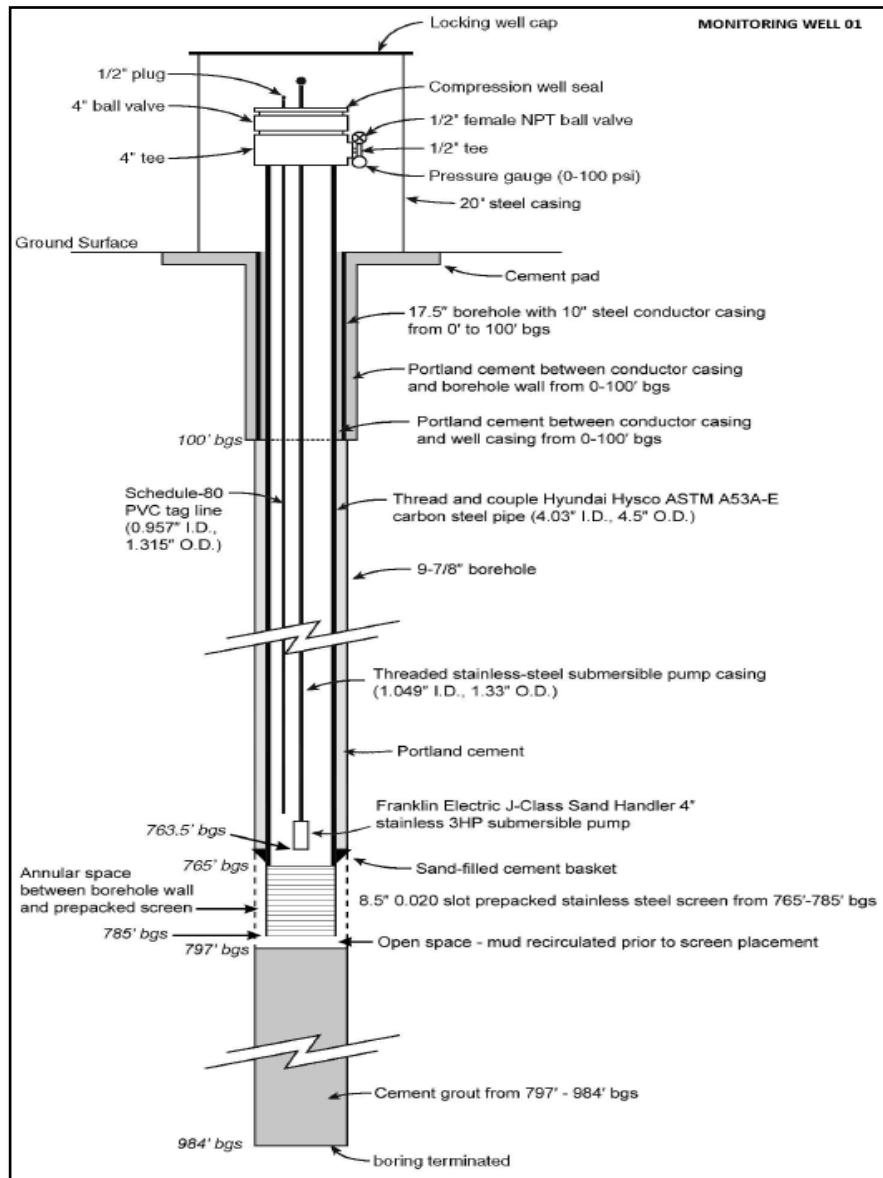
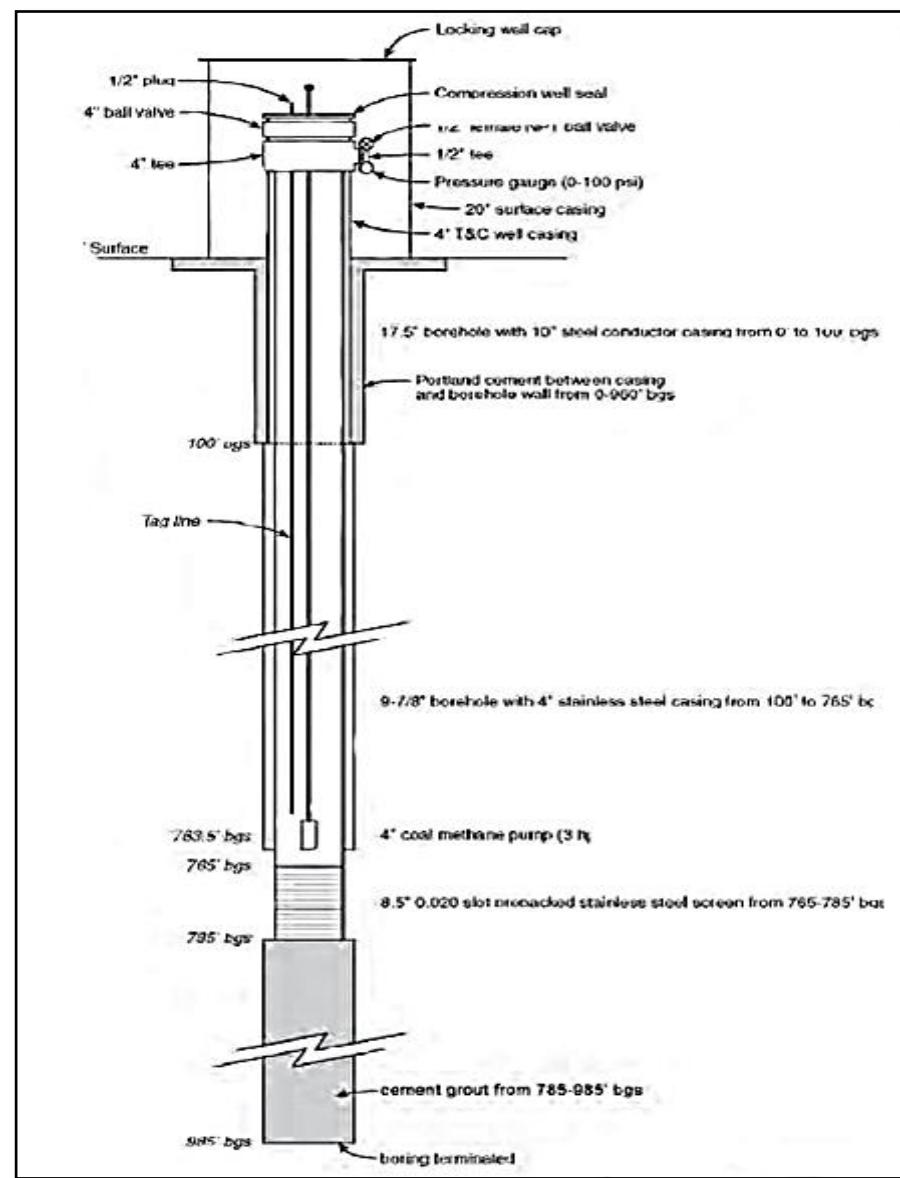
MW-01

- Construction diagrams for these monitoring wells in the Draft Report<sup>1</sup> contained numerous and significant errors, such as representing the hundreds of feet of the 4-inch riser casing as stainless steel, when in fact it was black painted/coated carbon steel casing. While this some of this information has now been corrected, most peer reviewers are likely unaware of these corrections;

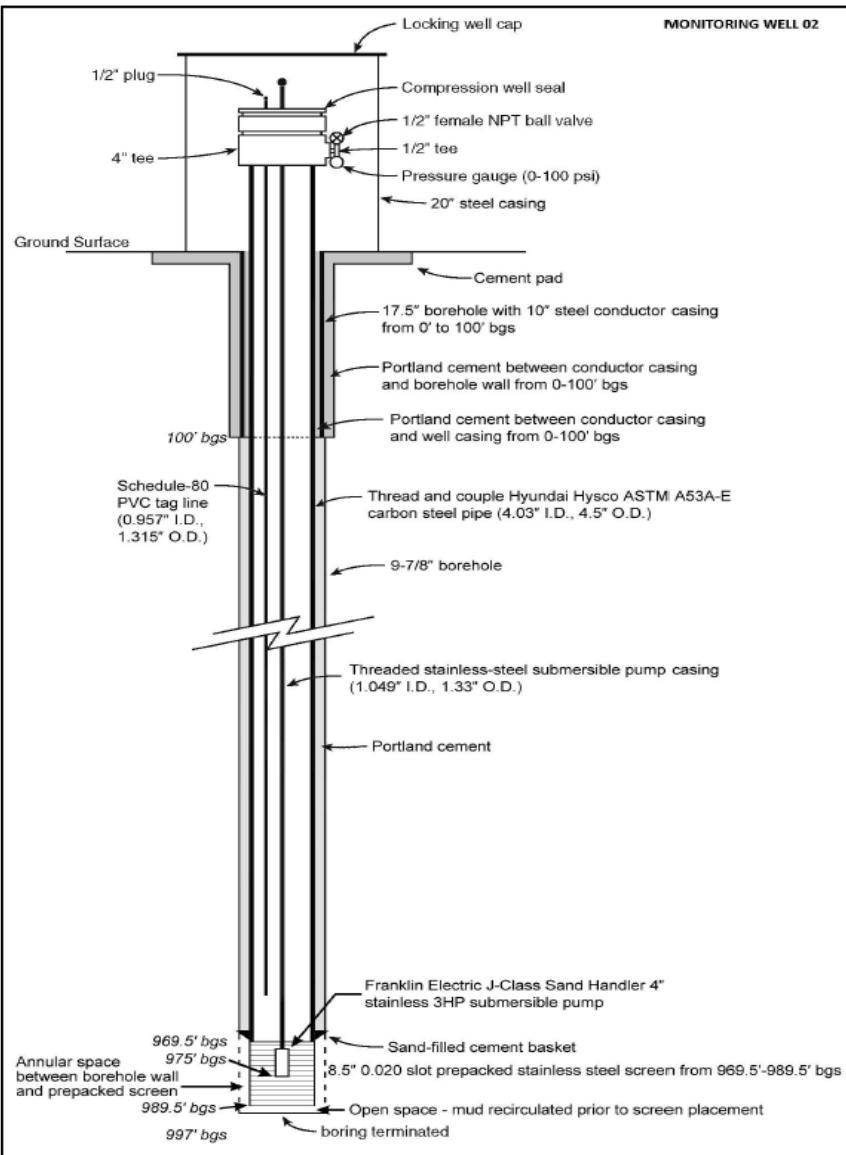
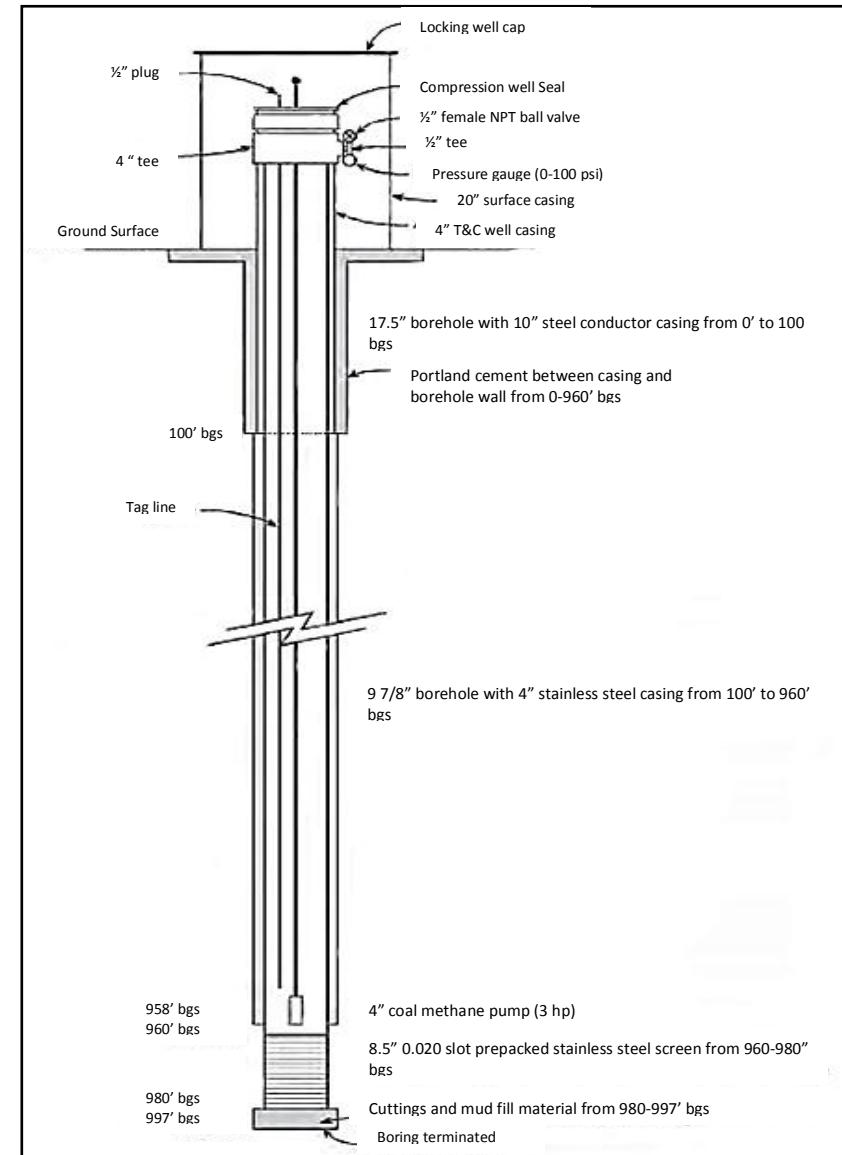
## MW-02

Monitoring well MW-02 construction diagram provided in the Draft Report<sup>1</sup> (besides EPA’s similar incorrect statements regarding use of the stainless-steel riser pipe versus what was actually used black painted/coated carbon steel), does not show the 1.8 foot long blue-painted (possibly black rubber or plastic lined) sand basket welded to the top of the well screen. No centralizers are shown on the on-site geologist field construction diagram<sup>19</sup> on figure 6b, or on the newly-revised (November 6, 2012) well construction diagram<sup>14</sup>. The well construction drawing (figure 6b) for MW-02 in the December 2011 Draft Pavillion Report<sup>1</sup> incorrectly indicates nothing but open space in the annular space between the 10-inch steel conductor surface casing set to 100 feet bgl and the 4-inch carbon steel casing. However, on the November 6, 2012 revised well construction diagram<sup>14</sup>, this annular interval is shown filled with Portland cement. None of the well construction diagrams for MW-02 indicate that powdered bentonite was added to the cement as required by the Work Plan<sup>5</sup>, but rather, all construction diagrams for MW-02 indicate only “***Portland cement***” was used.
